Manhole Inspection Summary

Manhole # S29AA1004MH

Insp Date: **12/11/06 5:13 PM**

Location Address: **3524 KESWICK RD**

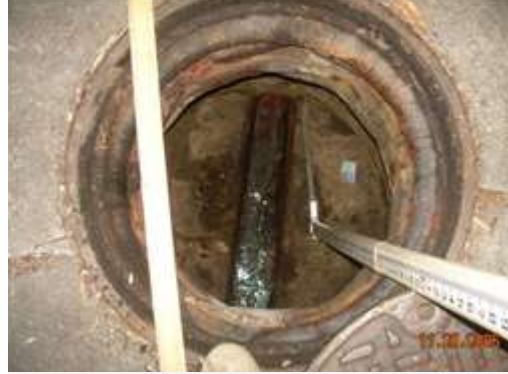
Top View

Frame leaks. Adjustment deterioration and infiltration. Corbel and Barrel infiltration. Corroded steps. Bench and

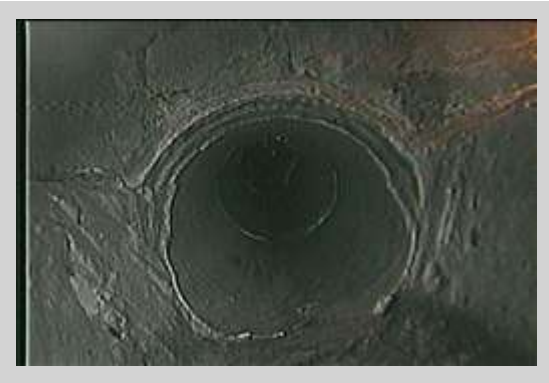
8 in. Circular Gravity Sewer Pipe Out @ 12 O'Clock

Pipe Material: **Clay** ☐ Pipe Lined

Invert Depth: **6.66** (ft.) Flow Characteristics: **Slow**

Infiltration: **Evidence** Pipe Seal Cond: **Unknown**

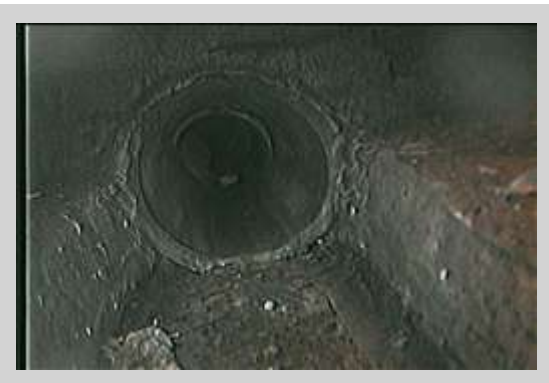
8 in. Circular Gravity Sewer Pipe In @ 6 O'Clock

Pipe Material: **Clay** ☐ Pipe Lined

Invert Depth: **6.09** (ft.) Flow Characteristics: **Slow**

Infiltration: **Evidence** Pipe Seal Cond: **Cracked**
